# REPORT 1133

## MECHANISM OF START AND DEVELOPMENT OF AIRCRAFT CRASH FIRES 1

By I. IBVING PINKEL, G. MERRITT PRESTON, and GERARD J. PESMAN

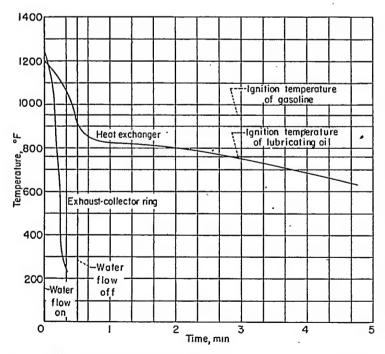
Before any of the aircraft were committed to this part of the program, the elements constituting the complete inerting system were checked for their functional effectiveness and for the time following crash impact that they can be expected to operate. Fuel and electrical shut-off systems required development to improve reliability and actuation speed. Extinguishing-agent injection systems were engineered for uniformity of distribution within the engine inlet manifold. The effectiveness of the water-spray system was evaluated in an operating engine nacelle by spraying oil on the incandescent exhaust-collector ring and, with the oil continuing to flow, observing the action of the water spray in quenching the resulting fire. The appearance of the oil fire before the water spray was turned on is shown in figure 34 (a). One second after the water spray was applied, the fire was extinguished as shown in figure 34 (b). Because the water spray was effective in putting out an existing fire, it was considered safe to assume that it would prevent ignition in the first place. With a water-spray system that provided effective coverage of the hot metal, ignition of gaso-

FIGURE 35.—Temperature-time history of hottest portions of exhaust system during crash test. Heat exchanger and exhaust-collector ring water-cooled and inerted.

line or oil did not occur when they were applied after the water-spray system was in operation.

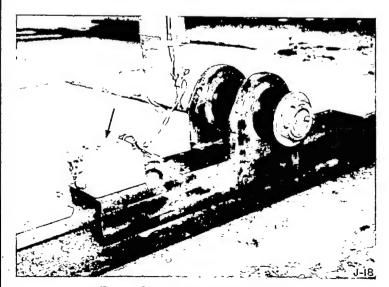
In the crash, the inerting system was actuated by a switch carried on the guide-rail slipper fastened to the nose-wheel strut, a photograph of which is shown in figure 36. A plywood target (fig. 37) was placed across the rail at the crash barrier to operate the switch after the propellers struck the barrier abutments. To provide a margin of safety against switch failure, a second switch connected in parallel was carried on the side of the airplane. The second plywood target shown on the angle iron support in figure 37 served this auxiliary switch.

Figure 36.—Inerting-system switch.

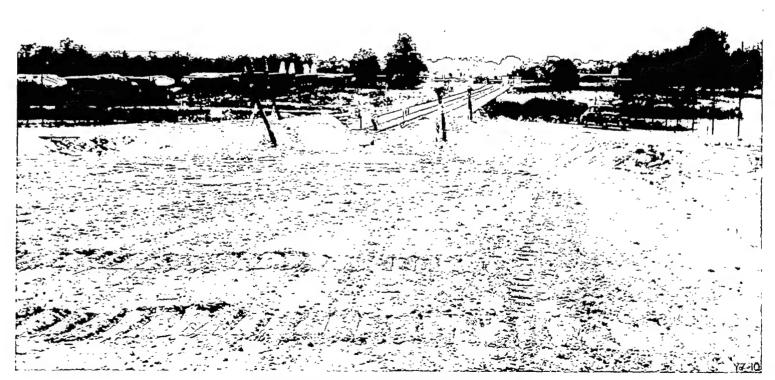
FIGURE 42.—Crash area for high-contact-angle crash.

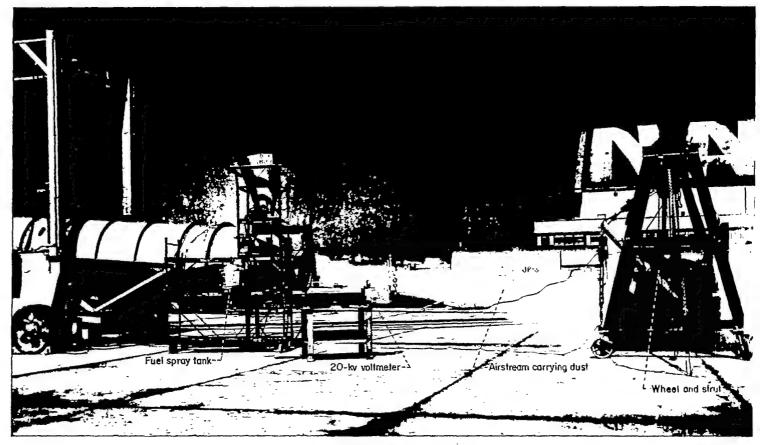
case was most likely produced by electrostatic discharge from the strut to the ground. Studies were made with the same wheel and strut, electrically insulated from the supports, as shown in figure 46. Air was blown over the wheel and strut assembly by the blower shown in the figure, and dust was metered into the air stream. A dust flow rate of 400 grams per second with an airspeed of 45 miles per hour past the strut generated 3900 volts, sufficient to produce sparks capable of fuel ignition in less than 0.75 second (fig. 47). In the crash, the wheel and strut traveled through the air at 43 miles per hour for 1 second, bounced on the rubber tire, and then traveled through the air for another 1-second period at approximately the same speed.

FIGURE 46.—Test setup to determine rate of accumulation of electrostatic charge on a landing-gear strut.

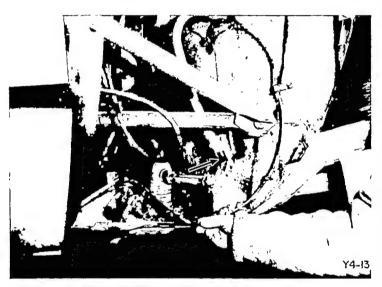
FIGURE 48.—Fuel line cut by flying propeller tip.
